Homeless Transitional Living Center
Department of Architecture - College of Architecture and
Urban Studies

Michael J. O'Brien
201 Cowgill Hall
Virginia Tech.
4.25.97

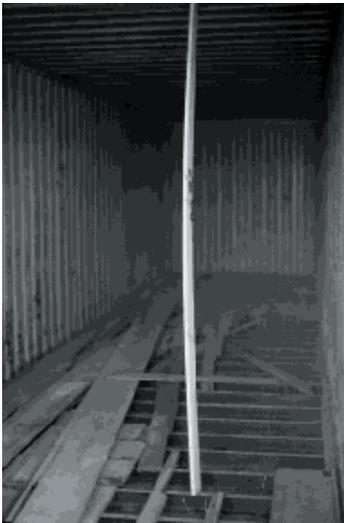
Container Interior as-delivered

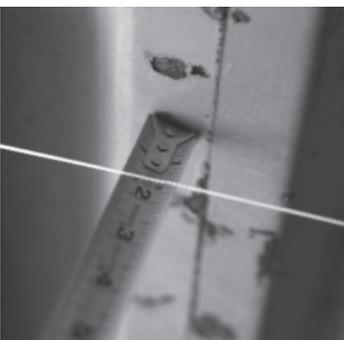
1 3/4 inch runout (bent) in container length

The initial assessment of this particular container showed two thirds of the flooring damaged beyond repair, a floor plate which was within one - quarter inch of being square, two badly damaged floor channels, two pinhole rust through locations, one door latch bent beyond operation, and exterior wall panels which projected into the container five - eighths of an inch on one side and projected out from the inside three - eighths inch on the other side.

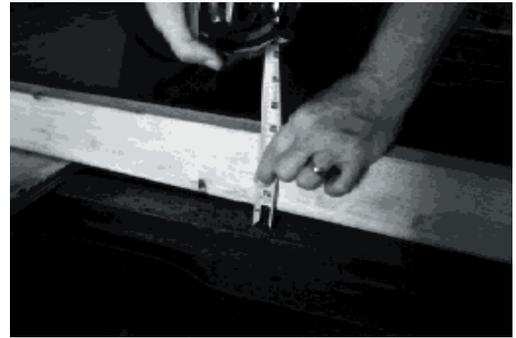
1 1/2" deflection in bent floor joist

The first demolition stage involved removal of the damaged existing flooring. The broken segments were removed and cut into four foot long segments for disposal. The small areas of unbroken floor were removed with a pry bar and hand held sledge hammer. Remaining fasteners were ground off flush with the floor channel. With the floor framing exposed to view, the damaged channels were repaired using two different processes. The first was cut using a plasma cutter from the bottom of the channel to but not through the top flange of the channel. The channel was then levered down to the appropriate elevation and the cut was filled with weld. The second channel was cut from the bottom of the beam to but not through the top flange with a reciprocating saw and bi-metallic blade. The cut channel was levered down to the appropriate elevation and a splice plate was attached to the bottom of the web by drilling holes in the web and bolting.

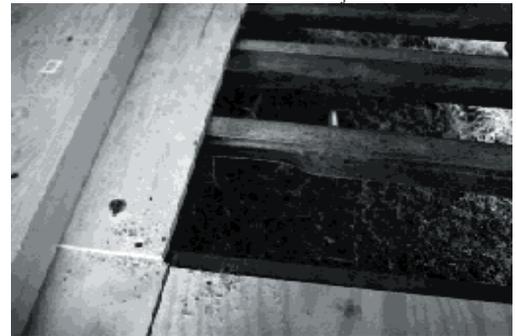
Damaged floor joist as-delivered

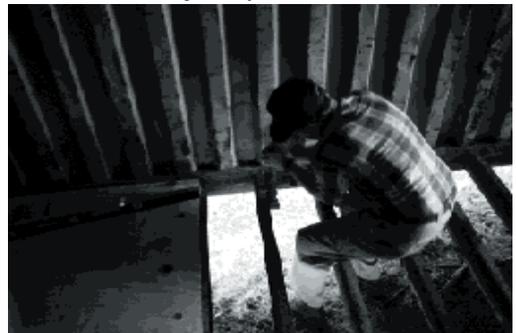
Manual joist straightening attempt

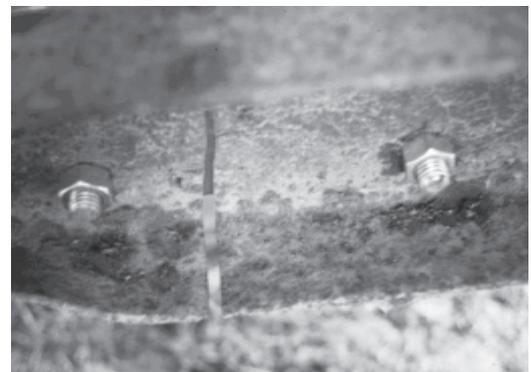
Joist straightened by cutting, bending, splicing

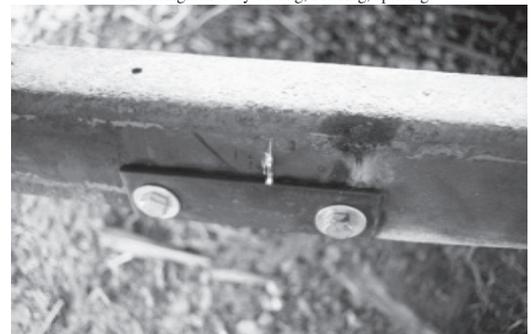
Splice plate after straightening

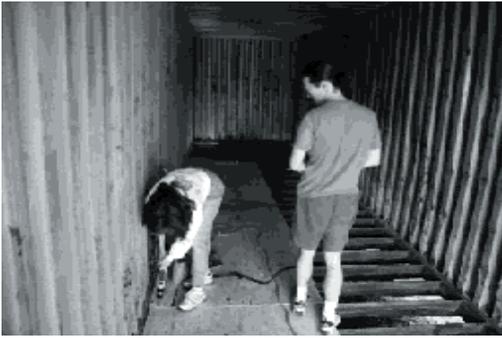
Master of Architecture students Tammy Felker and Tom Keeling install plywood subfloor

The flooring was replaced with 3/4 inch plywood sheets fastened to the floor channels with self drilling, self countersinking screws one foot on center along the perimeter and two feet on center in the panels interior.

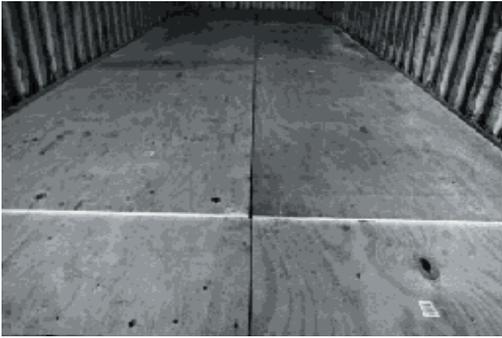
Joist deflection required removal, reinstallation of plywood after straightening the joist

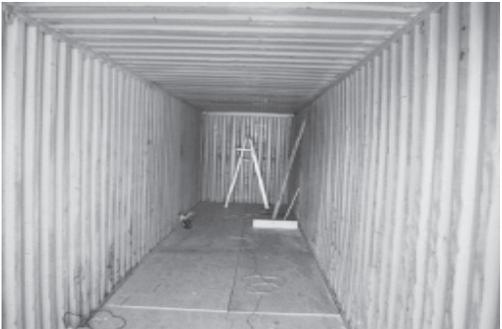
Plywood subfloor installed, topping slab to follow
