The contemporary masonry wall

- Designed to drain
- Kept dry with air cavity
- Expected to leak
- Uses foam plastic insulation

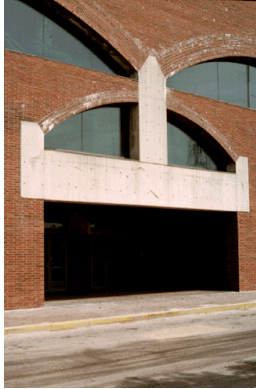
The white powder on the surface at the arches is efflorescence - salts dissolved out of the brick and mortar, which moved down the wall (following gravity) until the salt water hit an interruption in the wall (the arch.) The water soaked in the arch, evaporated through the arch face, leaving the salt deposits behind

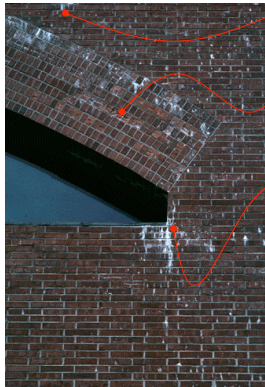
Water leaking from parapet coping above.

Soaked bricks froze and the faces spalled off.

No end dam at the flashing under this slate sill.

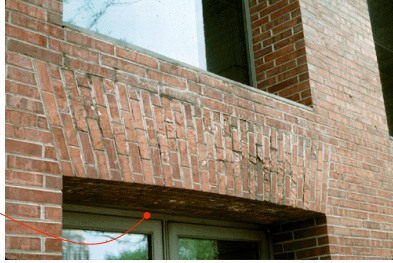
The deterioration is mostly cosmetic, but because these arches bear load, the weakening brick has to be replaced.

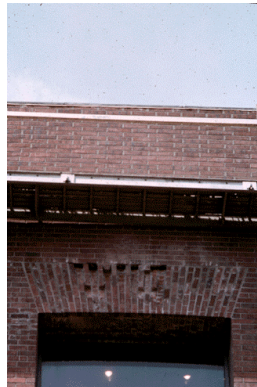
The slate coping at the parapet has been removed, new flashing installed below the coping and the slate replaced.

The bricks in the arch have to be cut out one at a time and new brick toothed in.

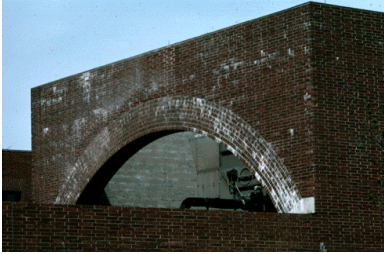
The worst case for the masonry was where it was exposed to moisture from both sides. What does the cooling tower behind this arch produce? How often?

This arch was deemed too badly damaged, and out of sight so it was covered up with cement stucco. How is the stucco doing?

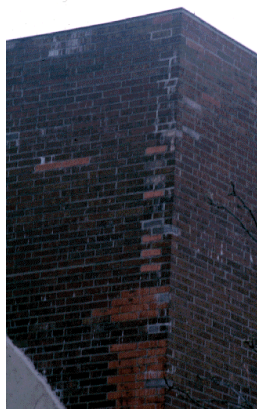
The corners of the cooling tower enclosure were patched with some not-very-close-to-matching brick....

Or bondo, or patching compound.

Damage like this is pretty hard to repair to original condition.
