Low Slope roofing

Most common low-slope

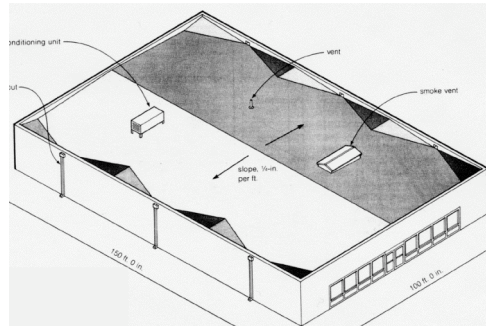
- Not flat
- Usual slope is 1/4" per foot
- Must be drained.... And drained (need separately piped backup drains with inlets no more than 2" above primary roof drains)

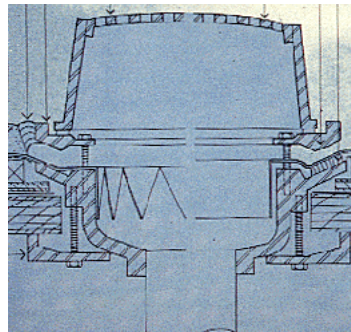
Roof Drains

-Locate in low points of roof...(NOT OVER COLUMNS!!!!!!!!!!!!!!)

- Strainer must project at least 4 inches above roof

-Strainer area must be at least 2 times the required drain pipe area

Some building codes require a **separately piped** overflow with an inlet **no more than 2 inches** above the primary drains

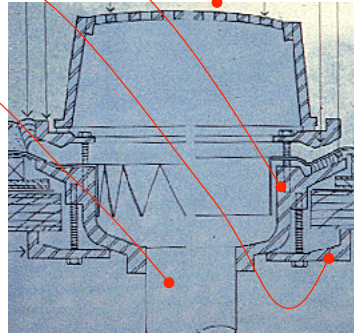
Roof Drain parts

Strainer (area twice the size of the drain pipe)

Hub or sump

Clamp to hold sump to roof deck

Drain pipe

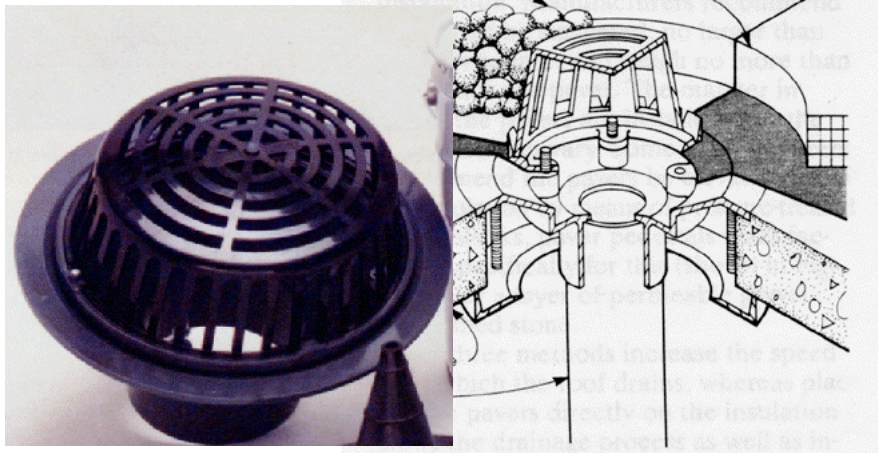
Protective mat
Insulation board
Gravel ballast

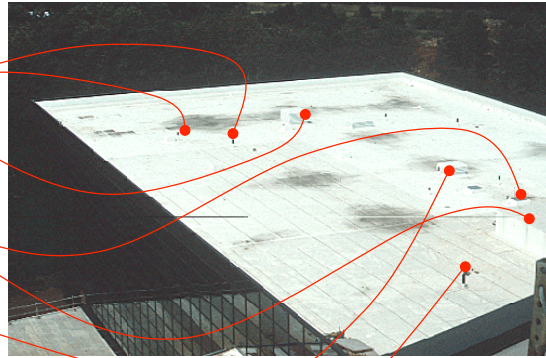
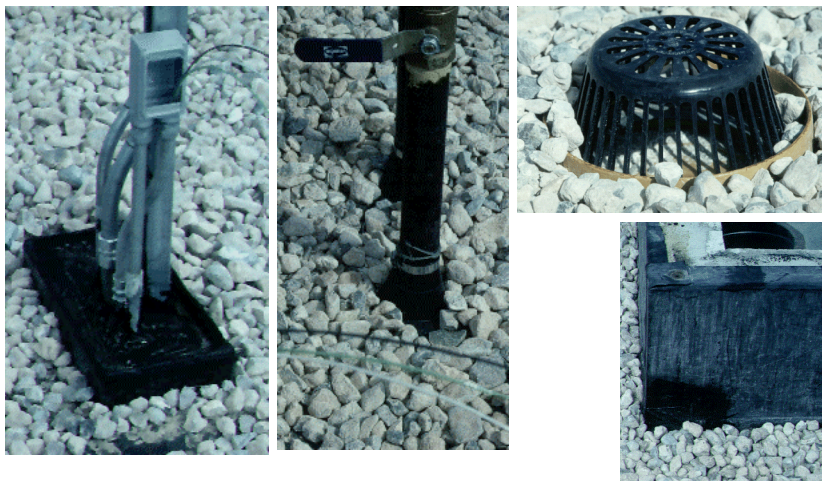
Pitch pan: A metal pan shaped enclosure (with a hole in the bottom) that is filled with a pourable sealant in the hope that it will flow around the irregular shape of the element(s) puncturing the roof. Should be filled to the top and sloped to run water away from the penetrations. Not desirable. Use large pipes and clamped boot/cones instead....usually leaks.

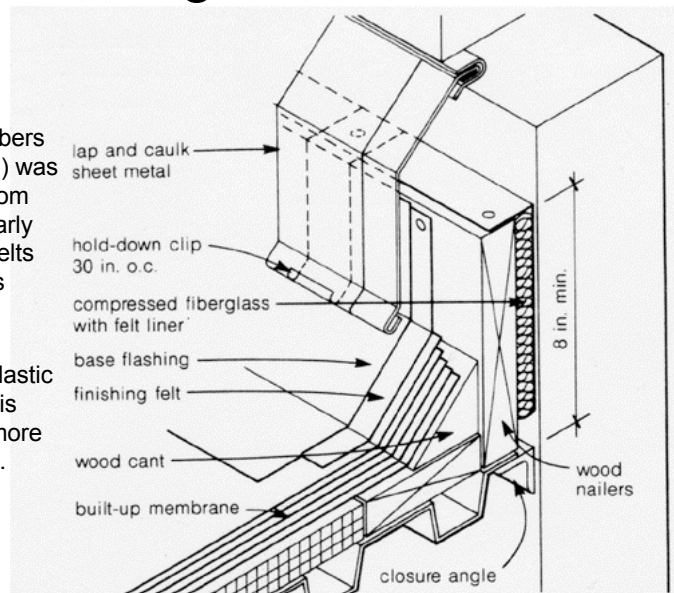
Watching them crack

- Asbestos fibers (reinforcing) was removed from the felts. Early fiberglass felts were not as flexible as asbestos.
- With less plastic bitumen, this produced more brittle roofs.

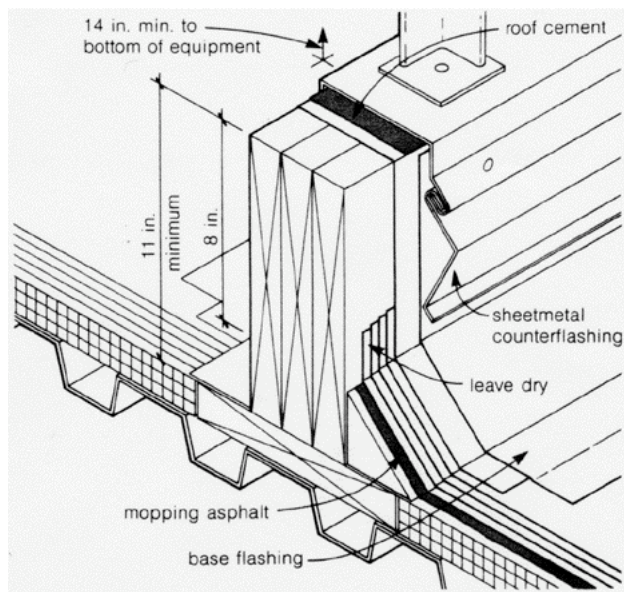
Stressed out roof

- Temperature changes (and internal flaws) were the major stresses for the BUR
- Even with carefully detailed joints to allow for movement the BUR's could fail in a rapid temp. change.
 - Chinook winds could change the temperature from -10 to + 50 in under six hours!
 - Jim Bofferding would take us up on roofs to watch them crack on Chinook days.
